Building Forensics

defect investigation & analysis

MOULD REPORT ON PROPERTY X

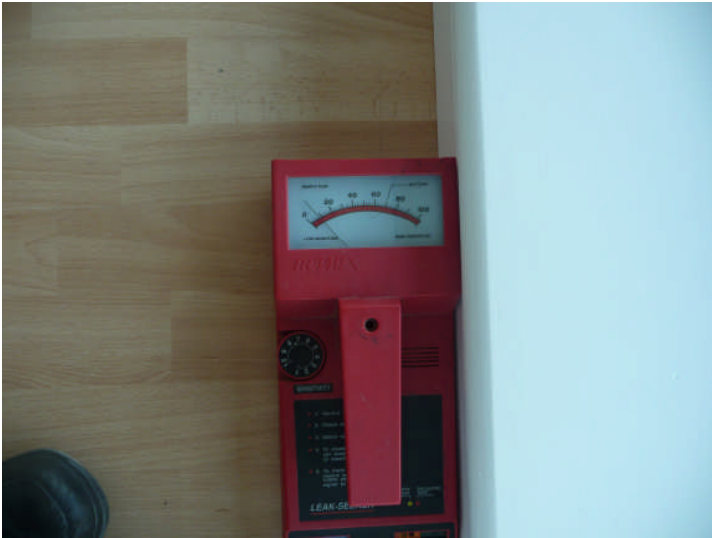
The floor of the lounge was scanned from the known or suspected wet areas to the furthest assumed drier areas. While scanning does not provide measured or meaningful scale of moisture content it can be utilised for comparison purposes.

17. Scale reading 10 moisture content

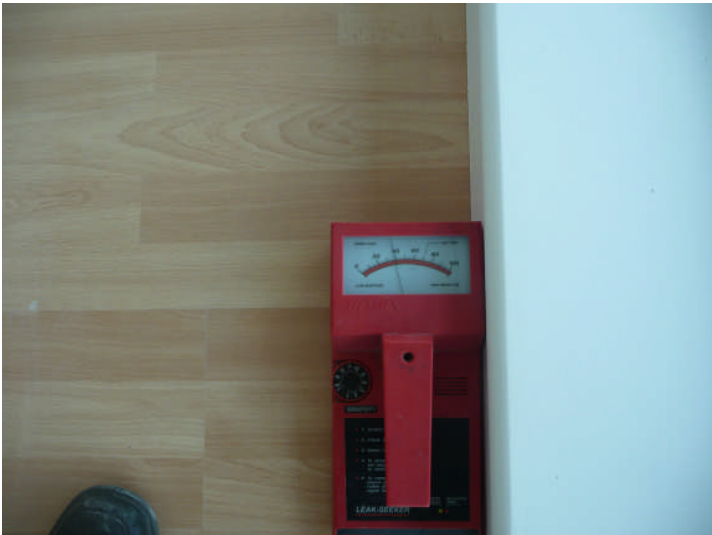
18. Scale reading 40 moisture content

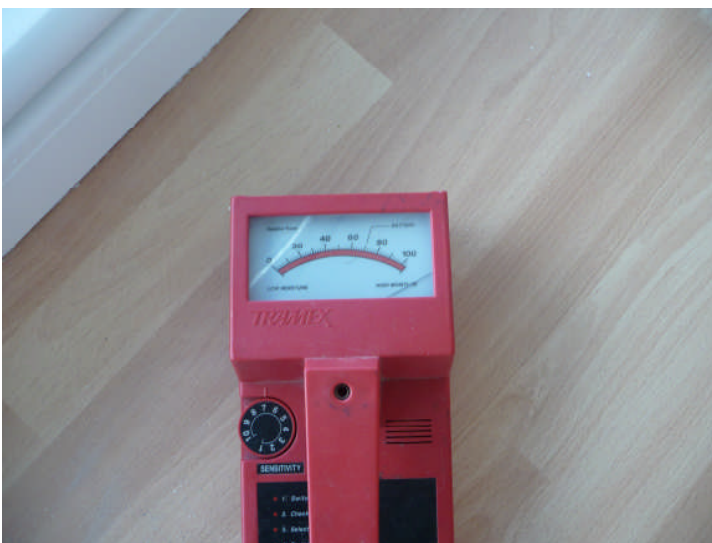
- a. Windows parallel to Thames 6 readings ranging from (20 to 100)
- b. Door area adjacent to hall (0)

19. Off scale 100 moisture content

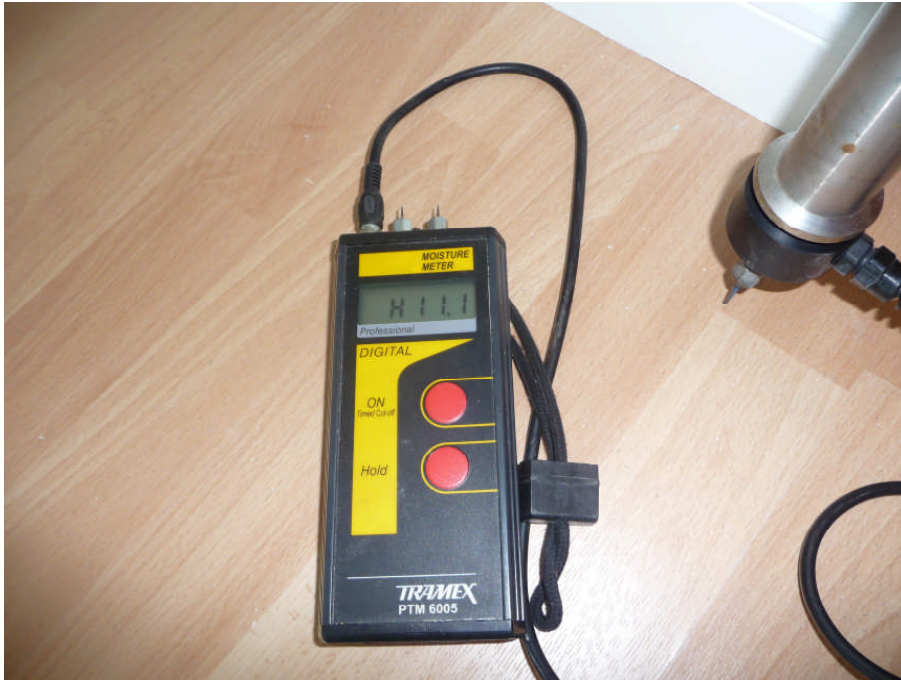
As a rule of thumb it is recognised that EMC⁴ values of concrete measured against a WME meter accept that concrete (screed) is wet over 7% moisture content.

- a. Adjacent to Thames side lounge window 26% mc
- b. Door area adjacent to hall 12% mc
- c.

20. Measuring screed at 11.1% WME at far end of lounge

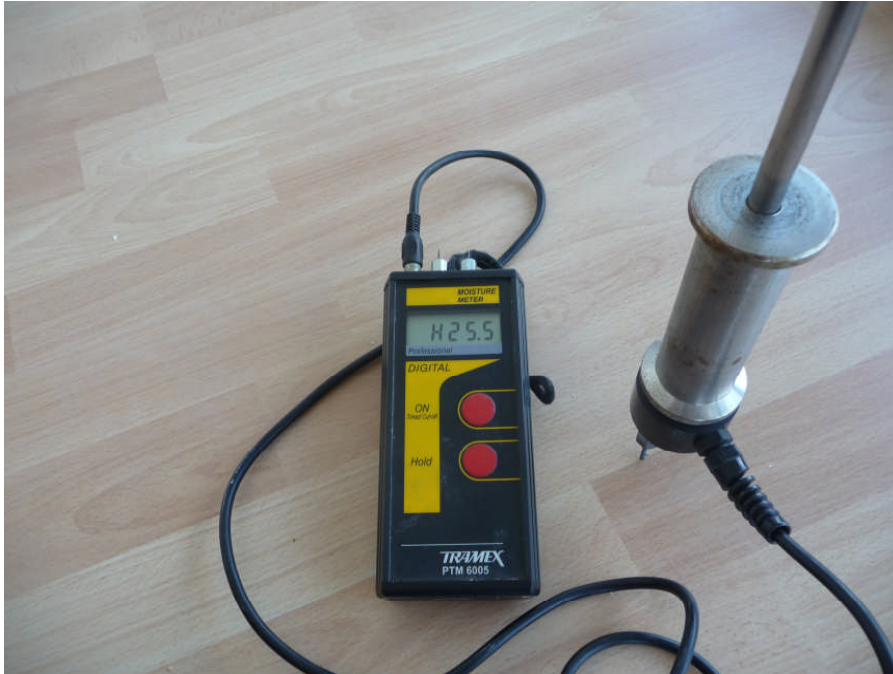
21. Screed shows 25.5% WME at window area of lounge

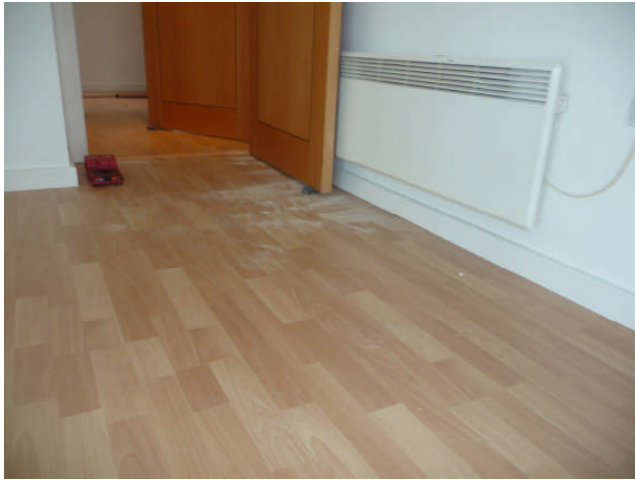
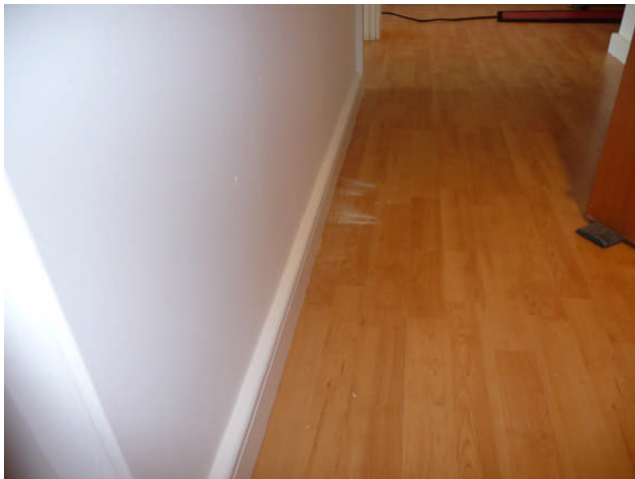
11. The application of negative pressure resulted in substantial entrainment dust being visible around room perimeter floors and especially external walls. This indicates possible failure of Part L building regulations in respect of building envelope and Fire regulations. This may also indicate that the property is exposed to weather ingress and Dew Point or condensation problems, which may result in mould or movement of contamination through interstitial cavities.

22. Showing dust entrainment under negative pressure

23. Showing dust entrainment under negative pressure

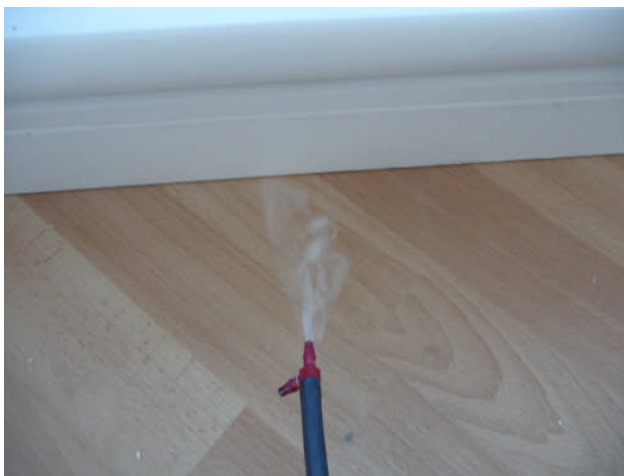
Therefore the negative pressure was replaced with positive pressure and smoke pencils were used to identify leakage points around windows at floor level. All windows appear to leak and this may be seen ingress points for moisture and cause future mould, corrosion and rot problems.

24. Showing chemical smoke being sucked out under windows under positive pressure

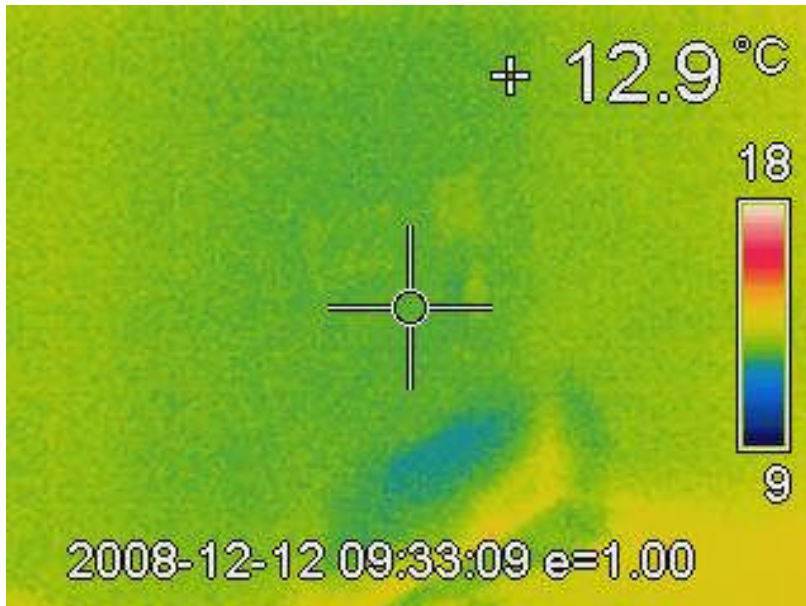
The lounge, now suspected of being wet and coupled to known building defects was subjected to an Infra red scan. This identified a cold patch adjacent to the windows which from moisture content analysis proved to be dry. This area was therefore subject to cold bridging or thermal insulation problems and the area was opened to find that insulation was missing as was fire protection. Externally it could be seen that external water proofing had not been applied to a satisfactory standard and that both air and moisture could readily enter into this room wall void and result in Dew point and mould. See photos 25-26

25. Infra Red scan showing cold spot below plug sockets (investigation required)

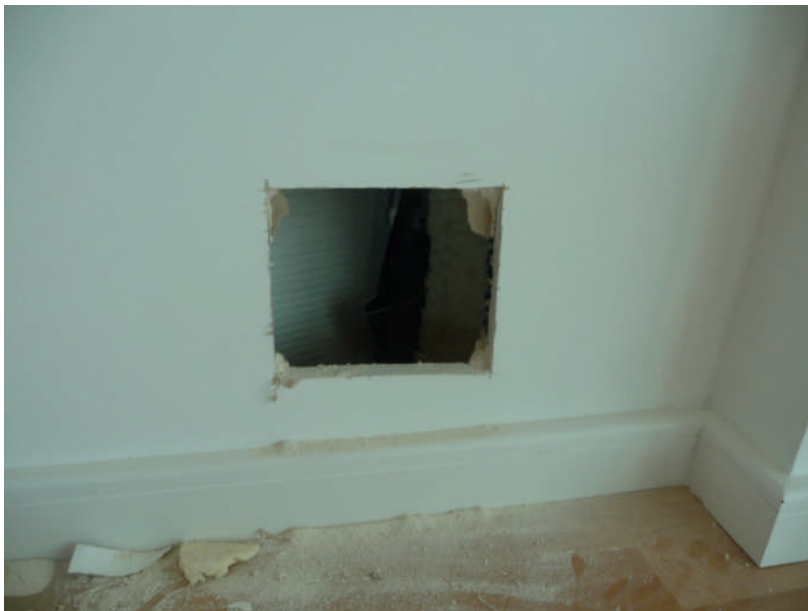
26. Lounge cold area from infra red survey showing missing insulation, vapour barriers etc.

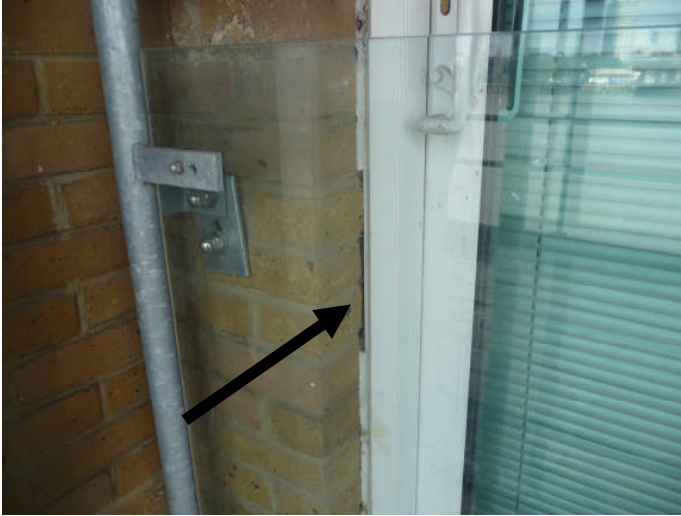
27. Outside view of photo (25- 26) showing gaps in brickwork and lack of weatherproofing (sealant)
